EXECUTIVE SUMMARY

TETHYS SUPPORTER

IMO no. 8741765

13-Feb-2019

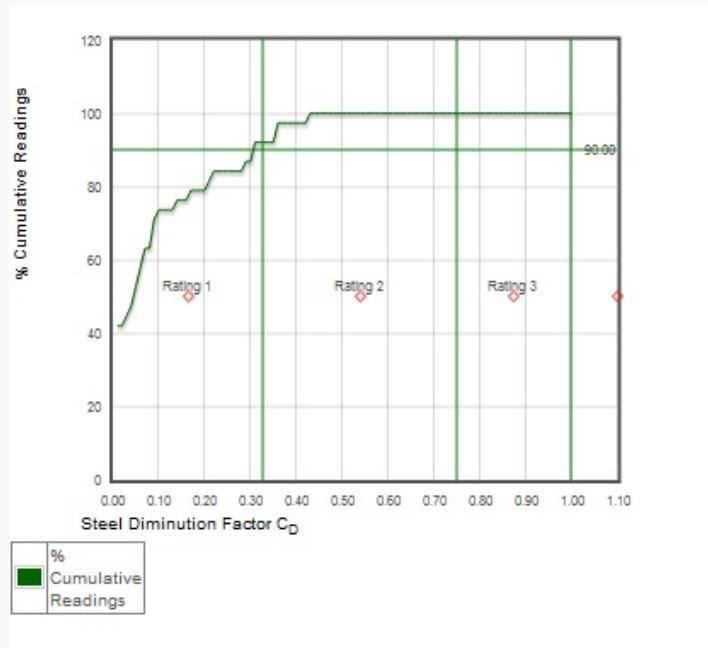
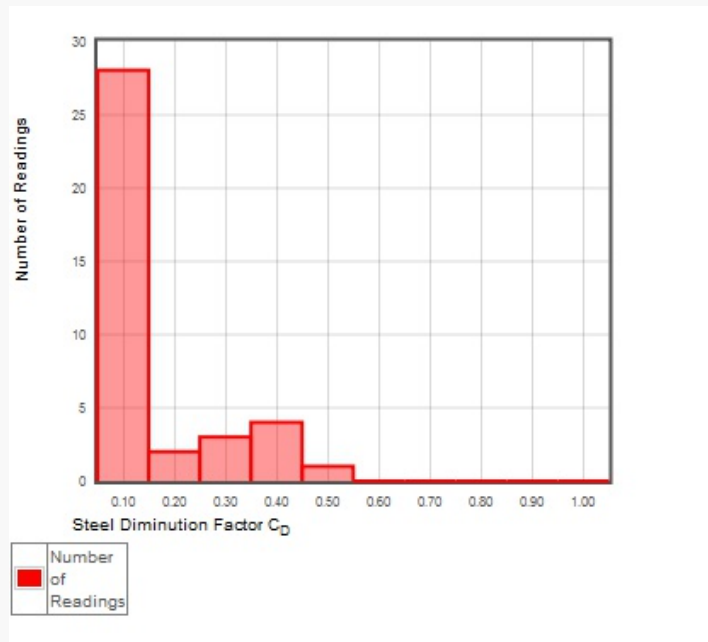
Assessment carried out for:	MAIN DECK PLATING AND LONGITUDINALS
Thickness measurements carried out in way of:	Main deck
Steel Diminution Factor C_D at 90% of Readings:	0.3
Substantial Corrosion Areas (YES/NO):	No

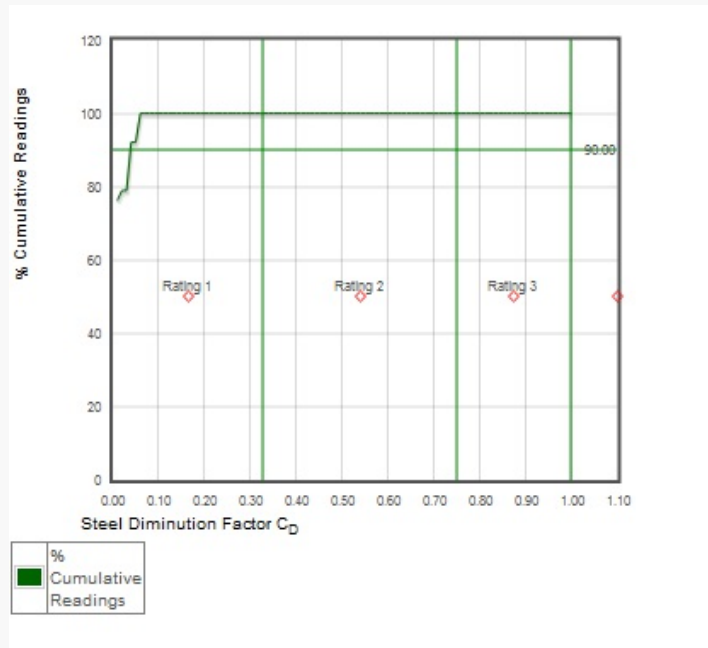
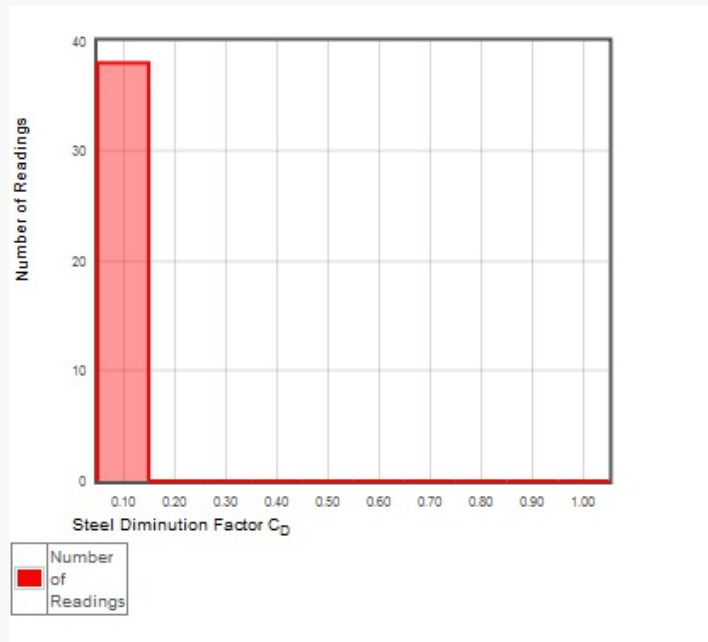
Assessment carried out for:	SIDE SHELL PLATING AND LONGITUDINALS
Thickness measurements carried out in way of:	Side shell
Steel Diminution Factor C_D at 90% of Readings:	0.03
Substantial Corrosion Areas (YES/NO):	No

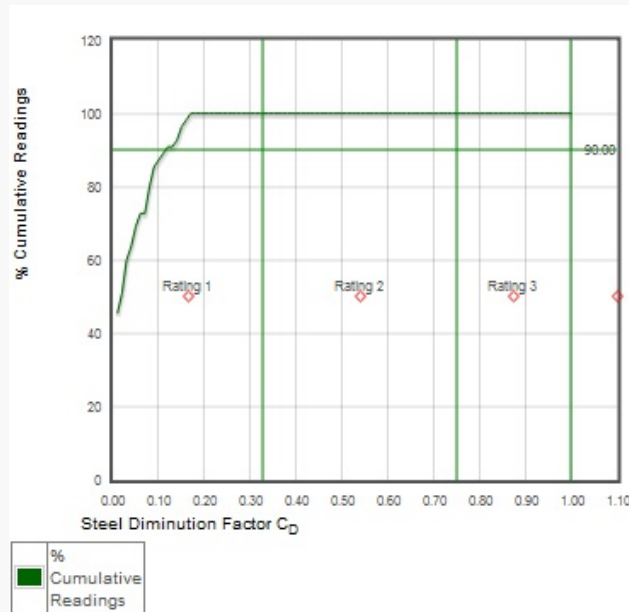
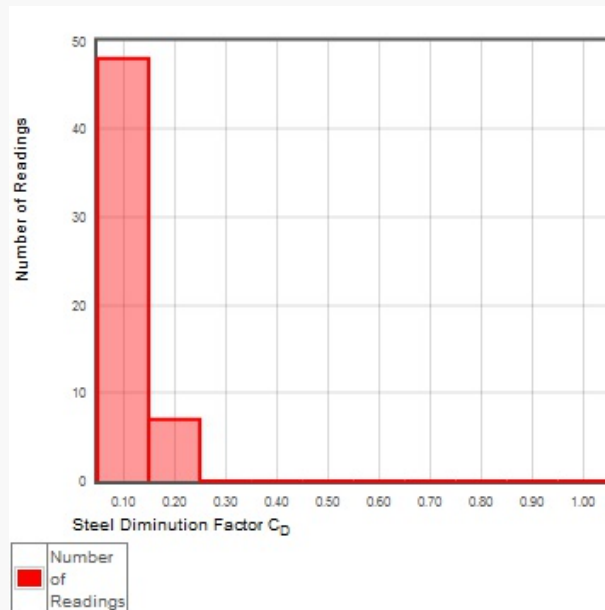
Assessment carried out for:	BOTTOM PLATING AND LONGITUDINALS
Thickness measurements carried out in way of:	Bottom
Steel Diminution Factor C_D at 90% of Readings:	0.11
Substantial Corrosion Areas (YES/NO):	No

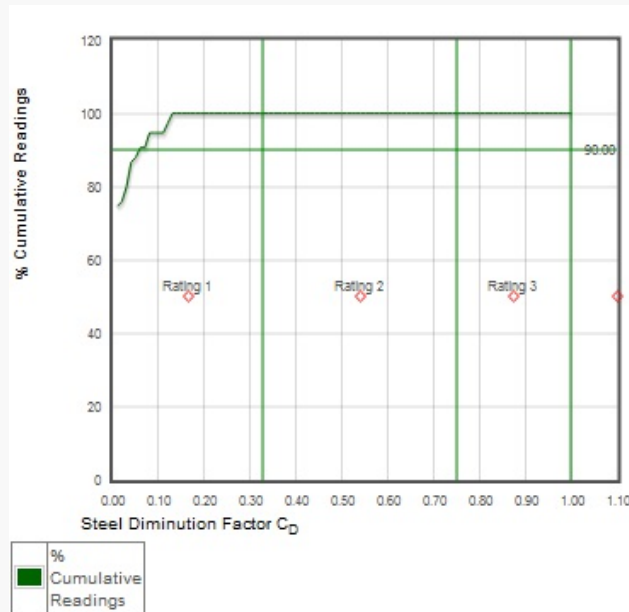
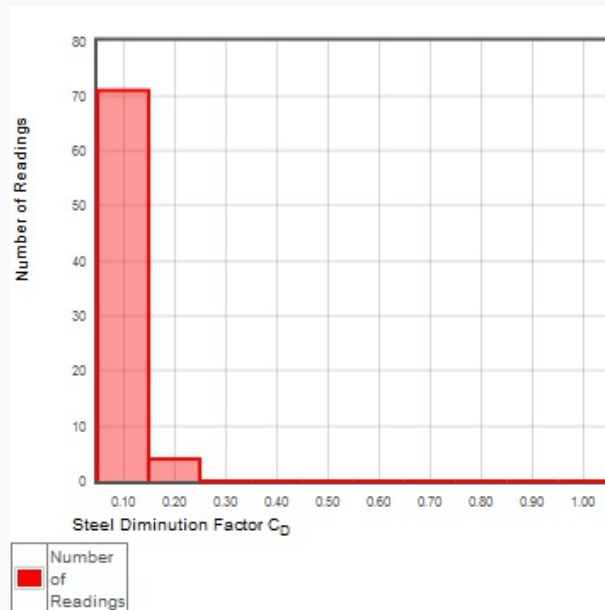
Assessment carried out for:	TRANSVERSE BULKHEADS
Thickness measurements carried out in way of:	Transverse bulkhead
Steel Diminution Factor C_D at 90% of Readings:	0.05
Substantial Corrosion Areas (YES/NO):	No

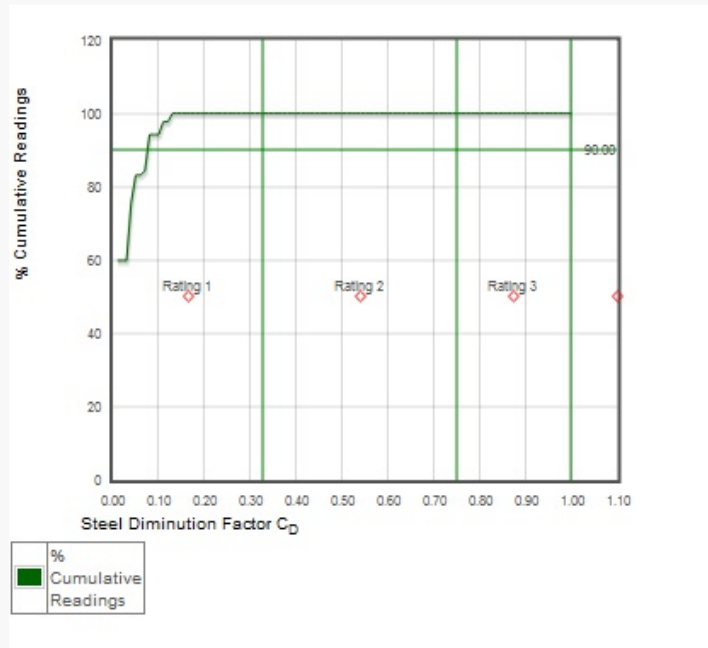
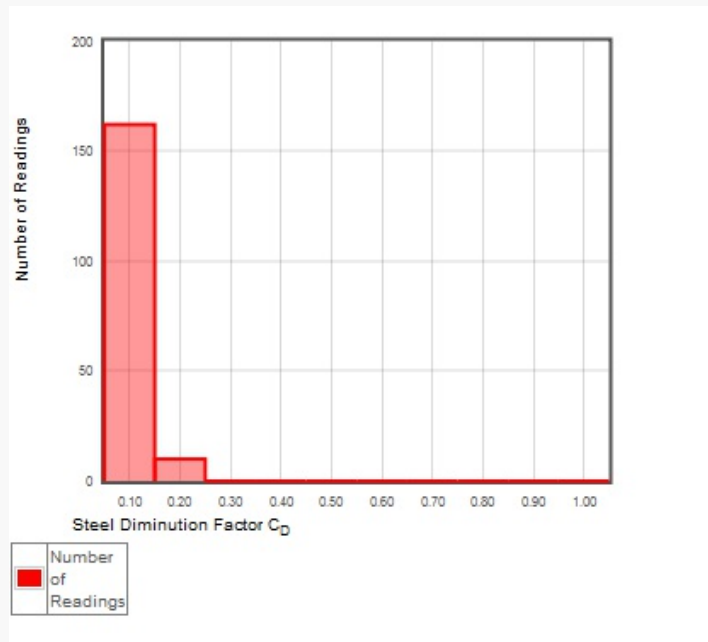
Assessment carried out for:	WEB FRAME RING
Thickness measurements carried out in way of:	Transverse web frames
Steel Diminution Factor C_D at 90% of Readings:	0.07
Substantial Corrosion Areas (YES/NO):	No

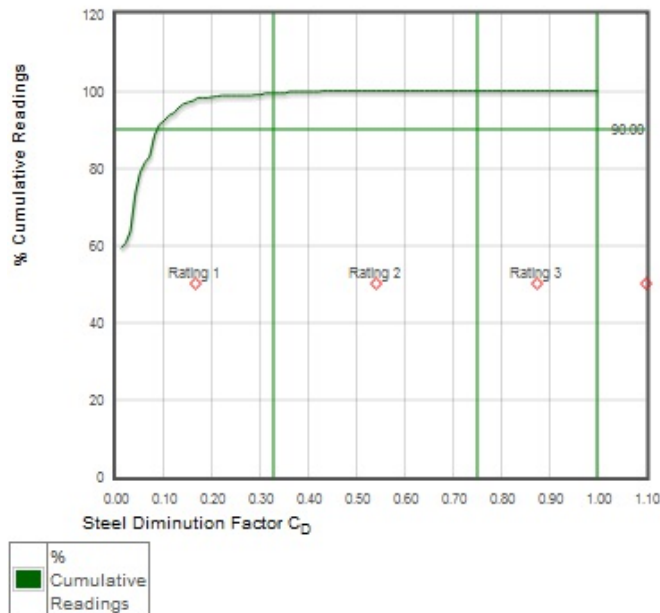
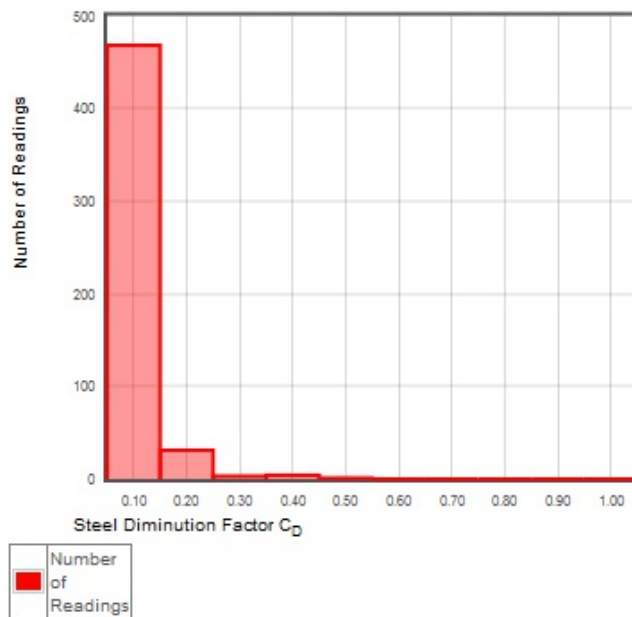
The overall steel diminution rating **2 "Good Condition"** has been assigned as the one corresponding to 90% of the readings as shown in the following cumulative diminution distribution curve:
