**TETHYS SUPPORTER**

**Structural Analysis for the Ship Condition Assessment Program**

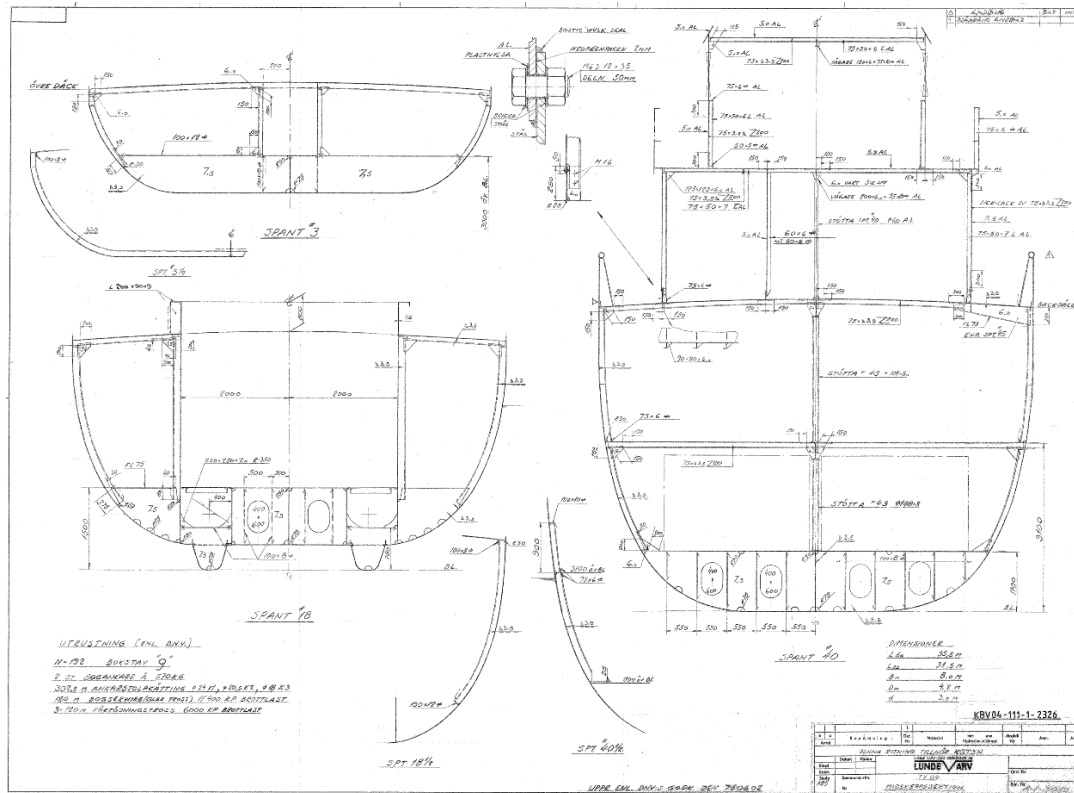
Figure.1 Midship Section

The analysis has considered all the plating and ordinary stiffeners belonging to the Midship Section, see Figure 1

These results indicate that the strength of subjected vessel is in compliance with the Rule requirements presently in force
