**TETHYS SUPPORTER**

**Structural Analysis for the Ship Condition Assessment Program**

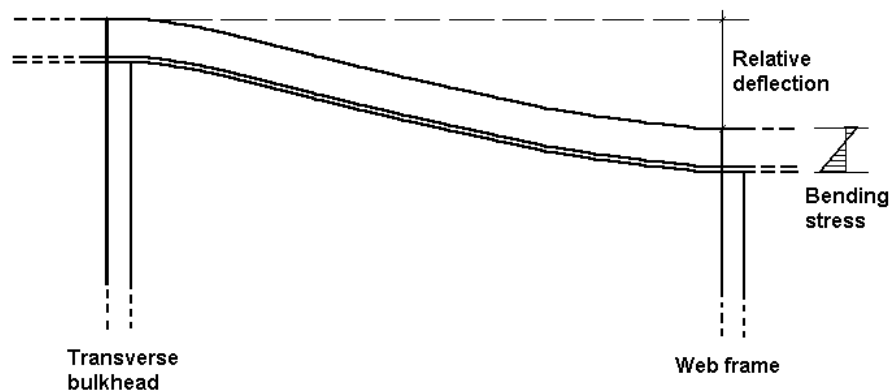
**Figure 2: Bending stress from relative deflections between transverse bulkhead and adjacent web frame**

- axial stresses due to the hull girder bending moments, both vertical and horizontal,
- bending stresses induced by the local wave loads supported by the stiffener, and
- for the connections with transverse bulkheads, additional bending stresses due to the relative deflections between the transverse bulkheads and the adjacent web frames (see Figure 2).
